Case 267 : Narrative

Case Vehicle (A): 2000 Mercury	Vehicle (B): 1998 Ford
Type: Grand Marquis, 4-door sedan	Type: Ranger, pickup
Driver: 87-year-old male	Driver: male-unknown age
CDC: 10-LYEW-3	CDC: 99-0000-0

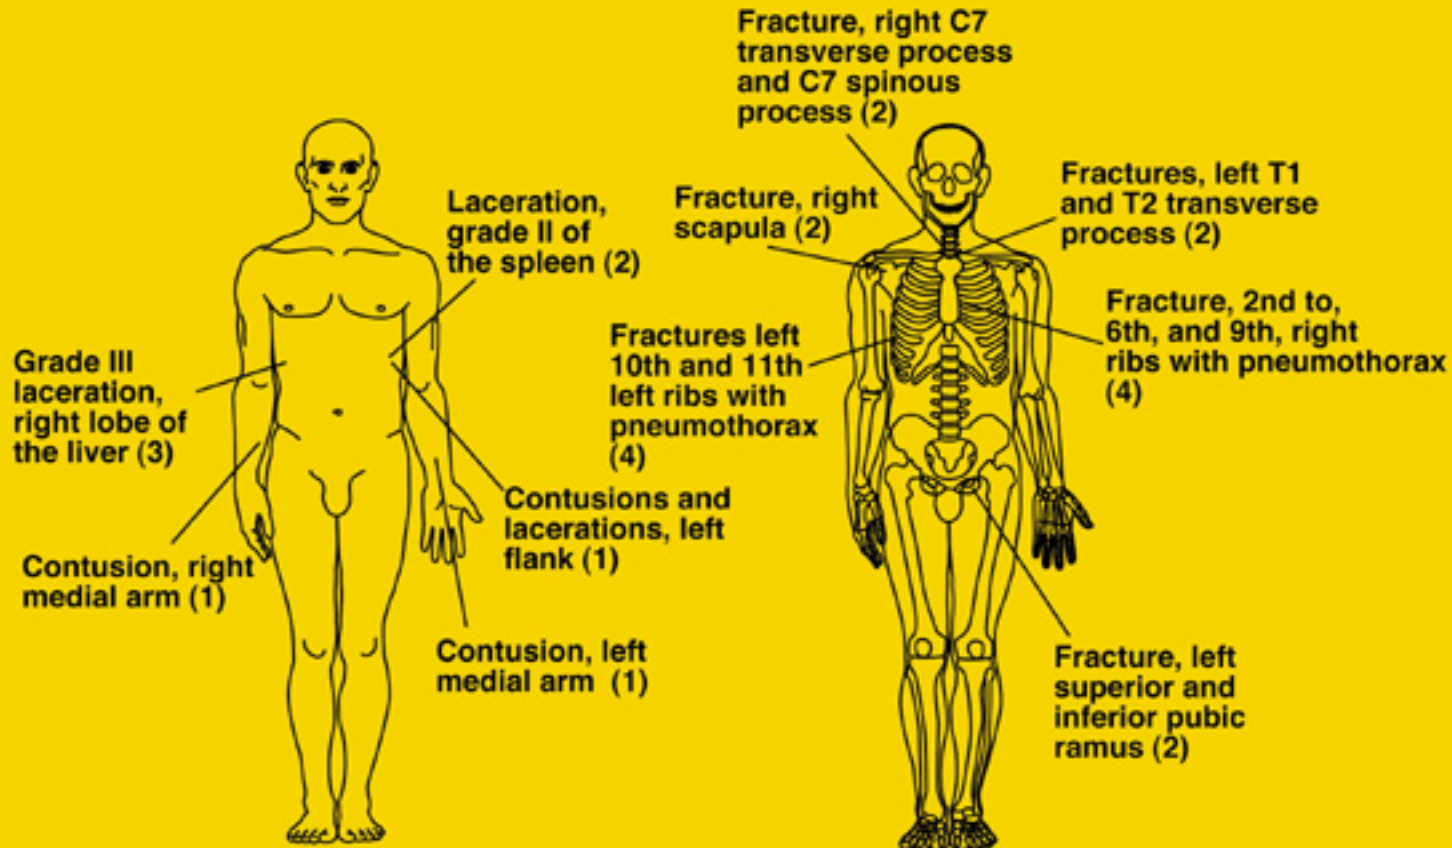
Occupant: Driver		Age: 87 years		Gender: Male	
Restraints: 3-point belt worn; airbag did <i>not</i> deploy		Stature: 180 cm (5 ft, 11 in)		Mass: 75 kg (165 lb)	
Injury Description		A.I.S.	Injury Source		
—		—	Definite	Probable	Possible
Fracture, right C7 transverse process		2	—	Lateral bending/impact forces	—
Fractures, left T1 and T2 transverse process fractures		2	Unknown	—	—
Fracture, C7 spinous process		2	Unknown	—	—
Fractures of the left 10th and 11th ribs with pneumothorax		4	—	Interior of left-front door	—
Laceration, grade II spleen		2	—	Interior of left-front door	—
Fractures, right 2nd to 6th and 9th ribs with pneumothorax		4	—	—	Right-front seatback and/or right-front passenger
Grade III laceration, right lobe of the liver		3	—	—	Right-front seatback and/or right-front passenger
Contusions, left flank		1	—	Interior of left-front door	—
Lacerations, left flank		1	—	Interior of left-front door	—

Fracture, right scapula		2	—	—	Right-front seatback and/or right-front passenger
Contusion, right medial arm		1	—	—	Right-front seatback and/or right-front passenger
Contusion, left medial arm		1	—	Interior of left-front door	—
Fracture, left superior and inferior pubic ramus		2	—	Left-front door armrest	—
Maximum A.I.S. Level		4	—	—	—
Injury Severity Score		29	—	—	—

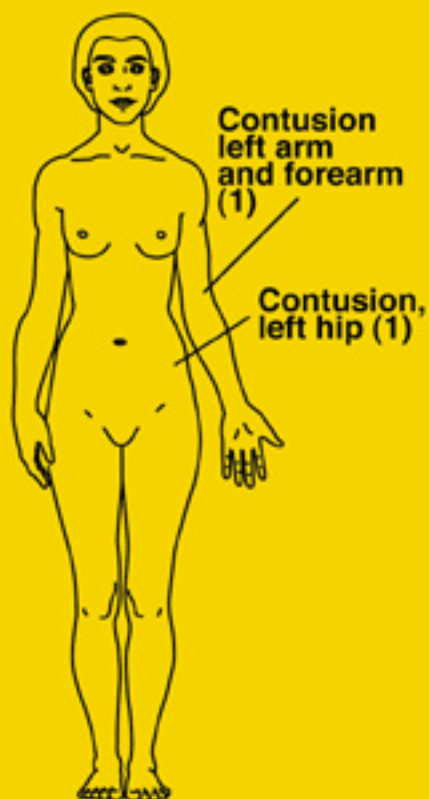
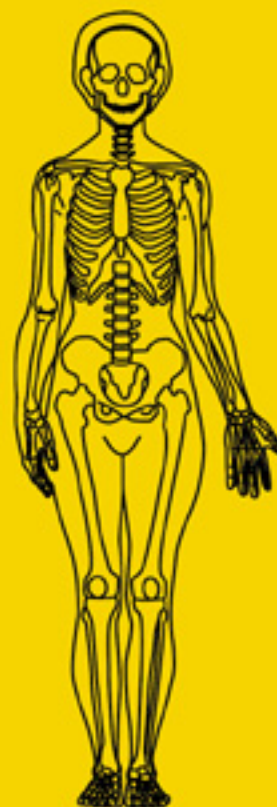
Occupant: Right front	Age: 81 years	Gender: Female		
Restraints: 3-point belt worn; airbag did <i>not</i> deploy	Stature: 173 cm (5 ft, 8 in)	Mass: 82 kg (180 lb)		
Injury Description	A.I.S.	Injury Source		
—	—	Definite	Probable	Possible
Contusion, left arm and forearm	1	—	—	Driver
Contusion, left hip	1	—	—	Driver
Maximum A.I.S. Level	1	—	—	—
Injury Severity Score	1	—	—	—

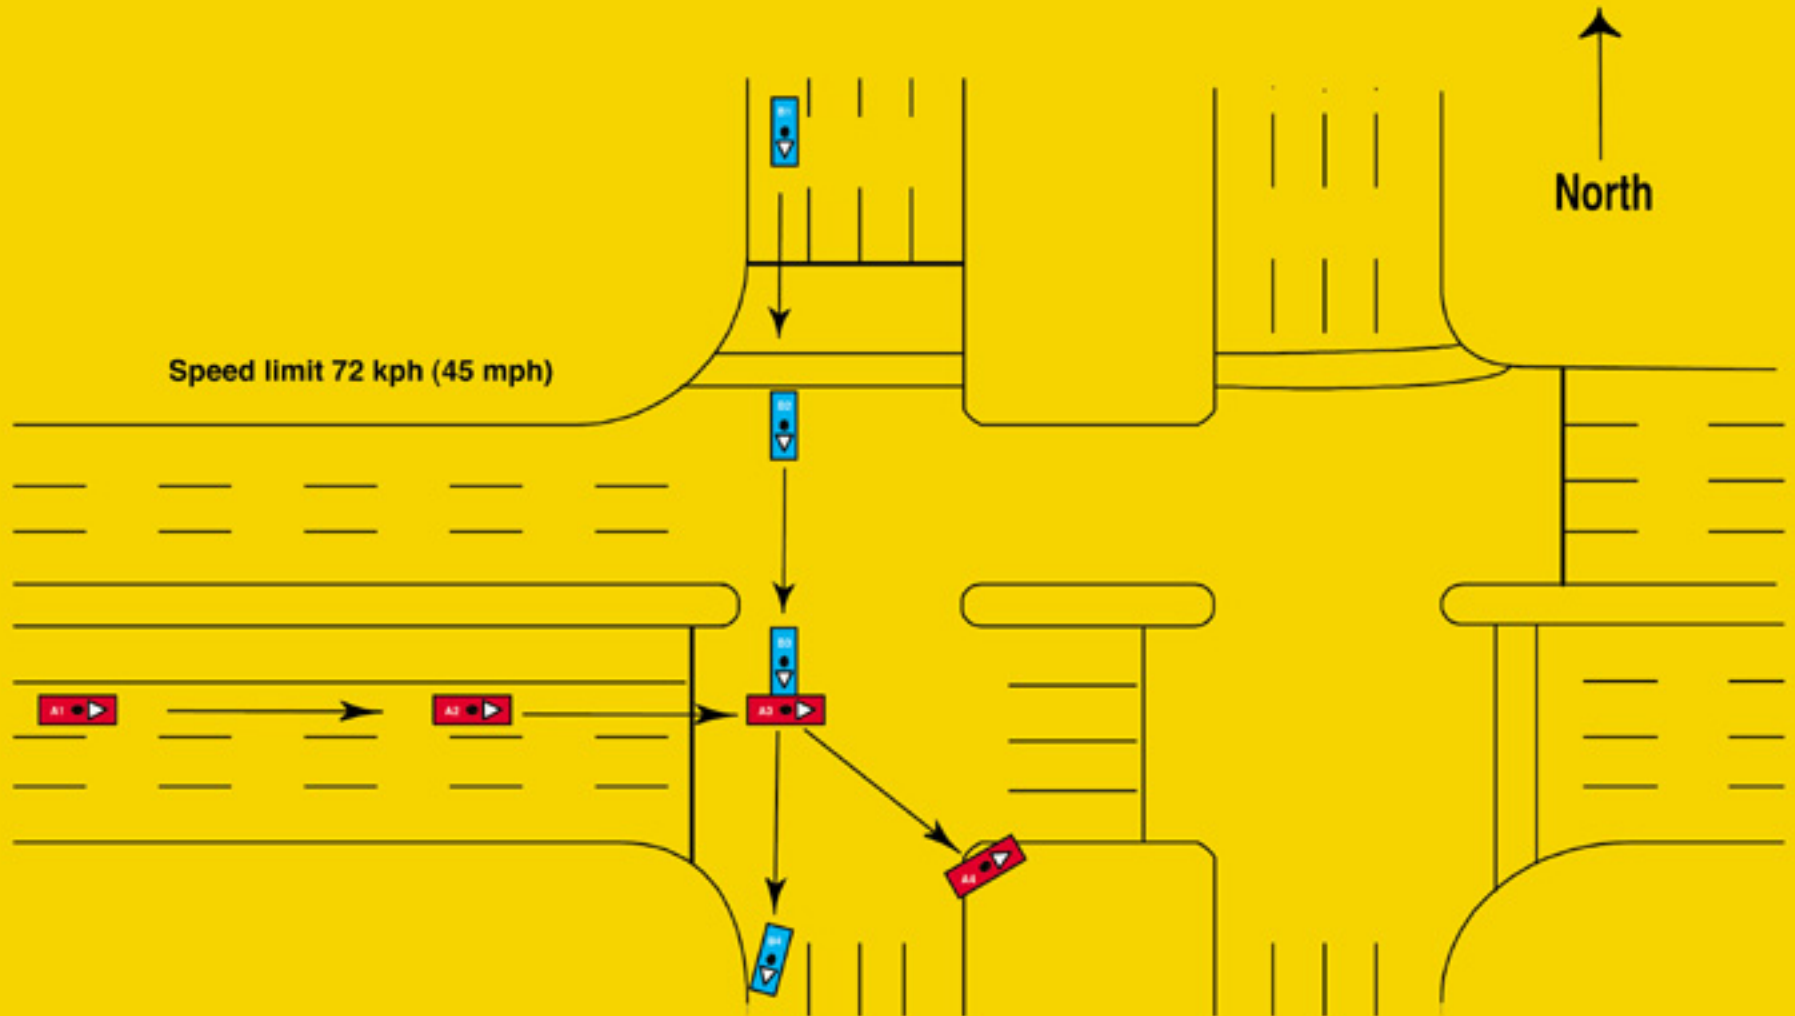
[1](#) Case vehicle (A) was travelling east in the inside eastbound lane of a seven-lane divided roadway, and was approaching a four-leg intersection. [2](#) Vehicle (B) was travelling south in the outside southbound lane of an eight-lane divided roadway and was approaching the same intersection. It was dark but lighted, and the roadway was dry and in good condition. As vehicle (B) entered the intersection, case vehicle (A) crossed its path and the front of vehicle (B) struck the left side of case vehicle (A). The impact caused case vehicle (A) to enter a counterclockwise rotation as it moved southeast through the intersection, before it came to rest at the southeast corner of the median. Vehicle (B) came to a rest just south of the southwest corner of the intersection. The driver and right-front passenger of case vehicle (A) were transported to a local hospital where they were admitted. The driver of vehicle (B) sustained "C" injuries, but was not transported for treatment.
